**Volumetric and
Sedimentation Survey
of
EAGLE MOUNTAIN
LAKE**

October 2018 Survey

October 2019

Texas Water Development Board

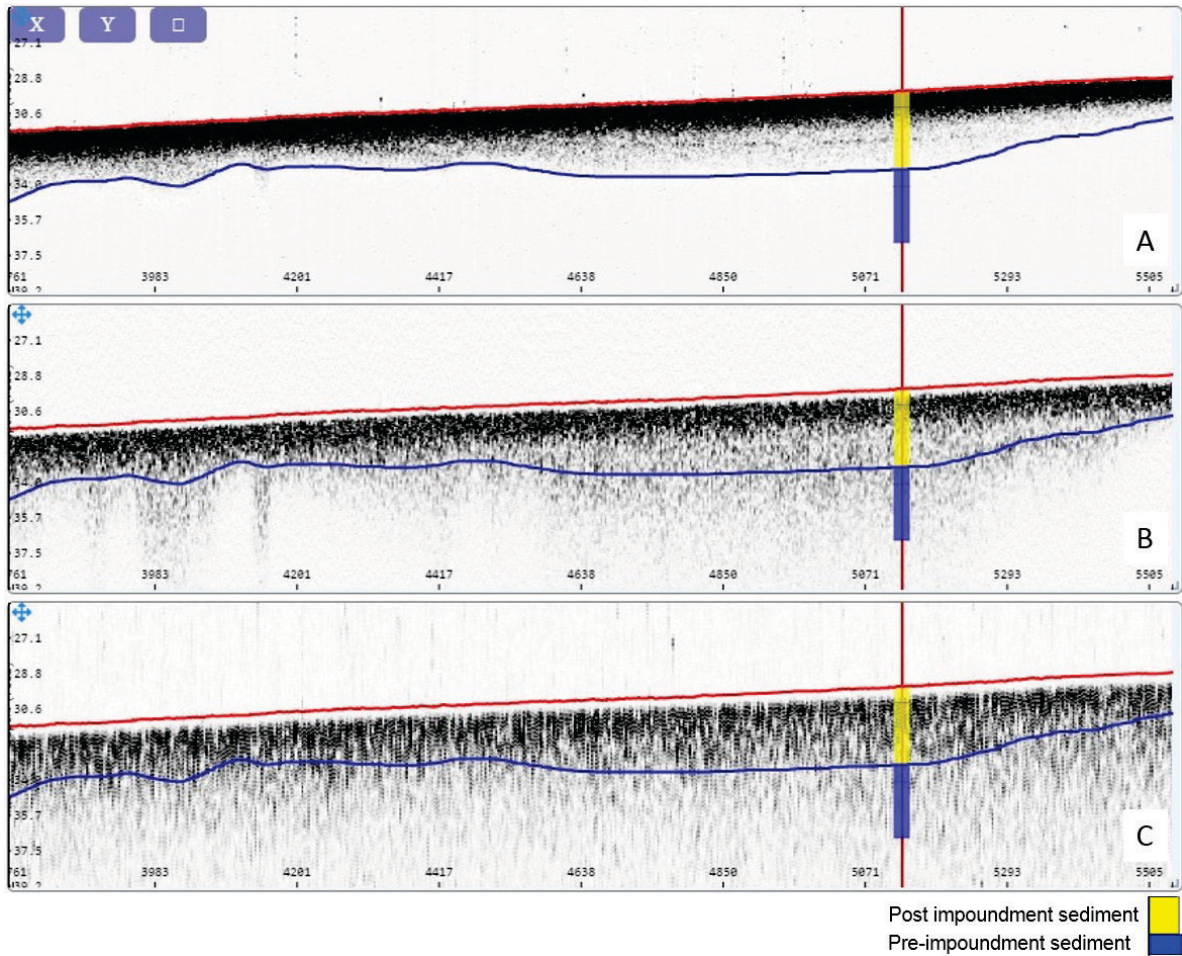
Figure 8. Comparison of sediment core EM-9 with acoustic signal returns. A) 208 kHz frequency, B) 50 kHz frequency, and C) 12 kHz frequency. The current surface in red and pre-impoundment surface in blue.

Figure 8 compares sediment core sample EM-9 with the acoustic signals as seen in Hydropick for each frequency: 208 kHz, 50 kHz, and 12 kHz. The current bathymetric surface is automatically determined based on signal returns from the 208 kHz transducer as represented by the top red line in Figure 8. The pre-impoundment surface is identified by comparing boundaries observed in the 208 kHz, 50 kHz, and 12 kHz signals to the location of the pre-impoundment surface of the sediment core sample. Many layers of sediment were identified during analysis based on changes in observed characteristics such as water content, organic matter content, and sediment particle size, and each layer is classified as either post-impoundment or pre-impoundment. The boundary of each layer of sediment identified in the sediment core sample during analysis (Table 2) is represented in Figures 8 and 9 by a yellow or blue box. A yellow box represents post-impoundment sediments. A blue box indicates pre-impoundment sediments that were identified.

In this case, the boundary in the 208 kHz signal most closely matched the pre-impoundment interface of the sediment core sample; therefore, the 208 kHz signal was used to locate the pre-impoundment surface (blue line in the top panel in Figure 8). Figure 9 shows sediment core sample EM-9 correlated with the 208 kHz frequency of the nearest surveyed cross-section. The pre-impoundment surface is first identified along cross-sections for which sediment core samples have been collected. This information then is used as a guide for identifying the pre-impoundment surface along cross-sections where sediment core samples were not collected.

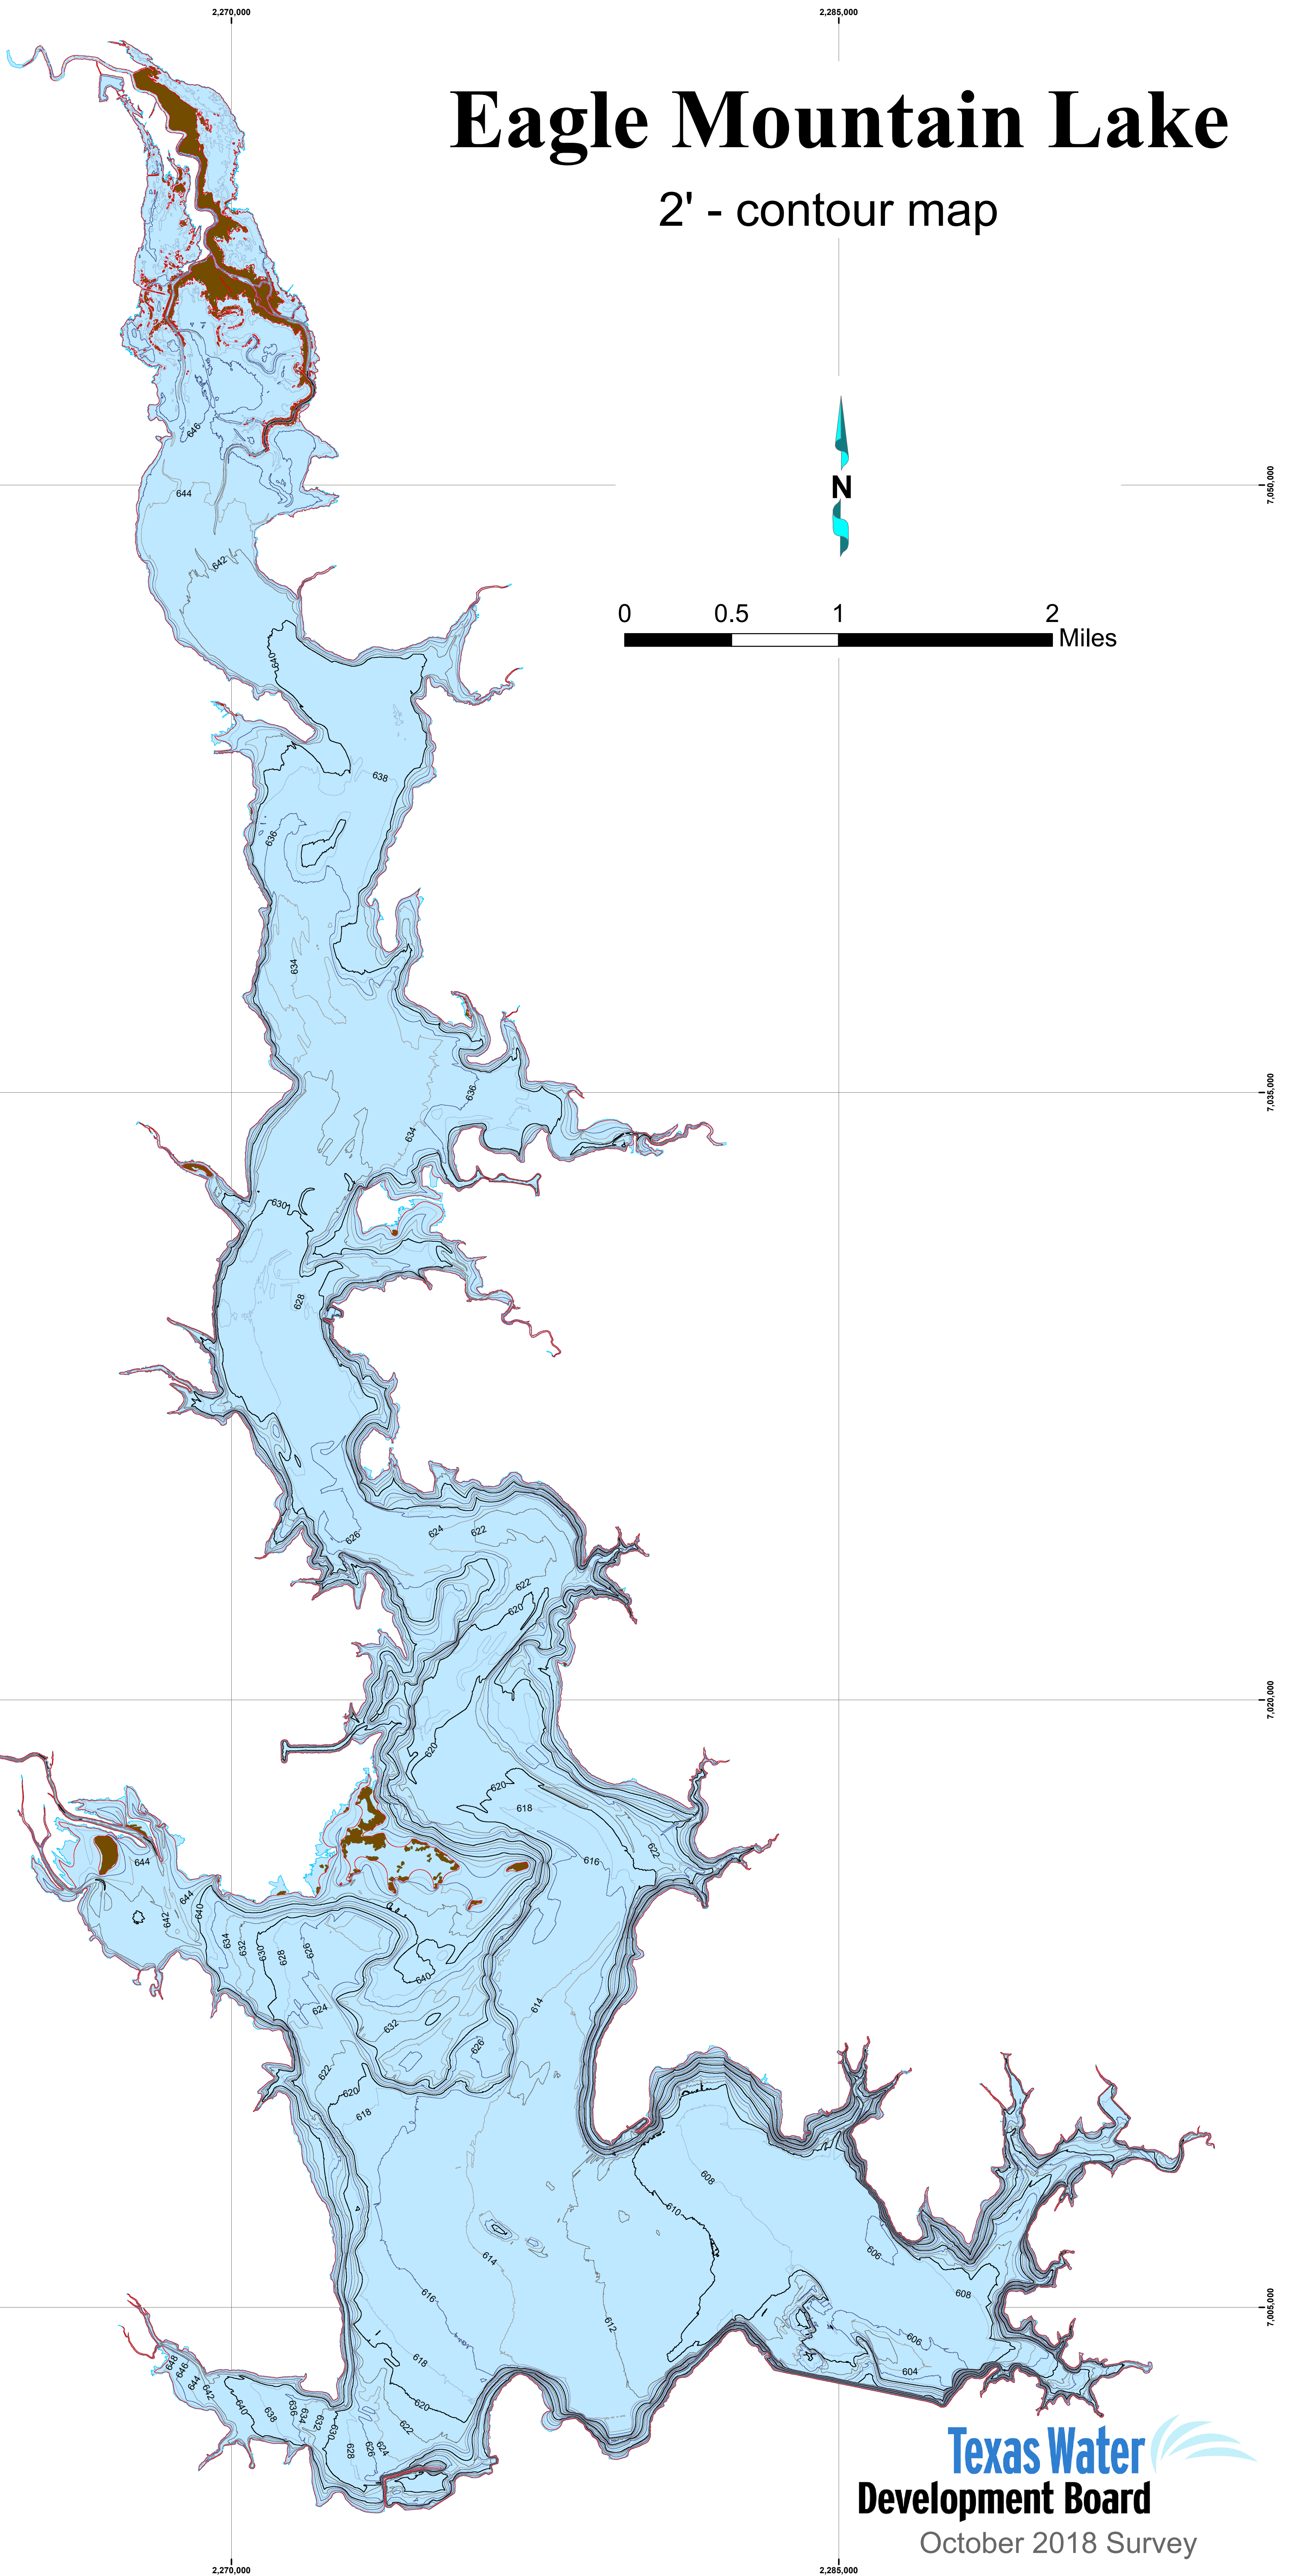
2' - contour map

The volumetric TIN model was converted to a raster representation using a cell size of 2 feet by 2 feet. The raster data then was used to produce three figures: (1) an elevation relief map representing the topography of the reservoir bottom (Figure 4); (2) a depth range map showing shaded depth ranges for Eagle Mountain Lake (Figure 5); and, (3) a 2-foot contour map (Figure 6).
